Chapter 10

DESCRIPTION OF IMPACTED RESOURCES IN THE RENDIJA CANYON TRACT

BACKGROUND FOR THE RENDIJA CANYON TRACT ASSESSMENT

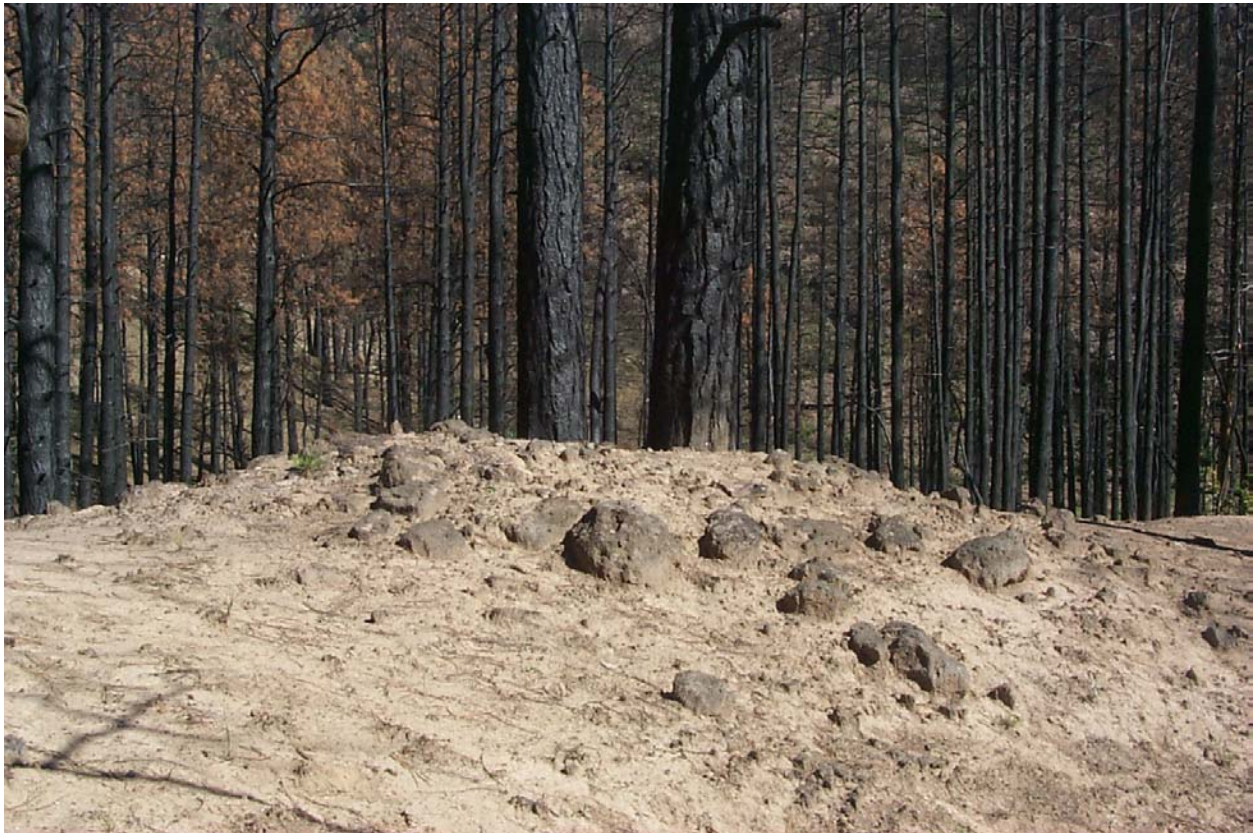
LA 70025. This site (Figure 10.2) was last visited in 1992 as part of a LANL Environmental Restoration Project (McGehee et al. 1993). The site consists of two one-room structures (3 m by 3 m and 2 m by 2 m) separated by 7 m. Both structures are composed of mostly unshaped tuff blocks. The site is located on the edge of a low ridge finger in western Cabra Canyon among ponderosa pine trees. Based on ceramics the site probably dates to the Late Coalition or Early Classic. The area around the site was severely burned. There are 40+ snags and partially burned trees in the area; two of these have the potential to damage the site should they fall. All of the masonry on the site is heavily soot damaged, although less than 5% is heat spalled. The duff has been burned off from around the site. As some of the tuff blocks have already started migrating downslope, the absence of duff serves to increase an already high erosional threat.

Figure 10.2. LA 70025, view of larger fieldhouse, facing north.

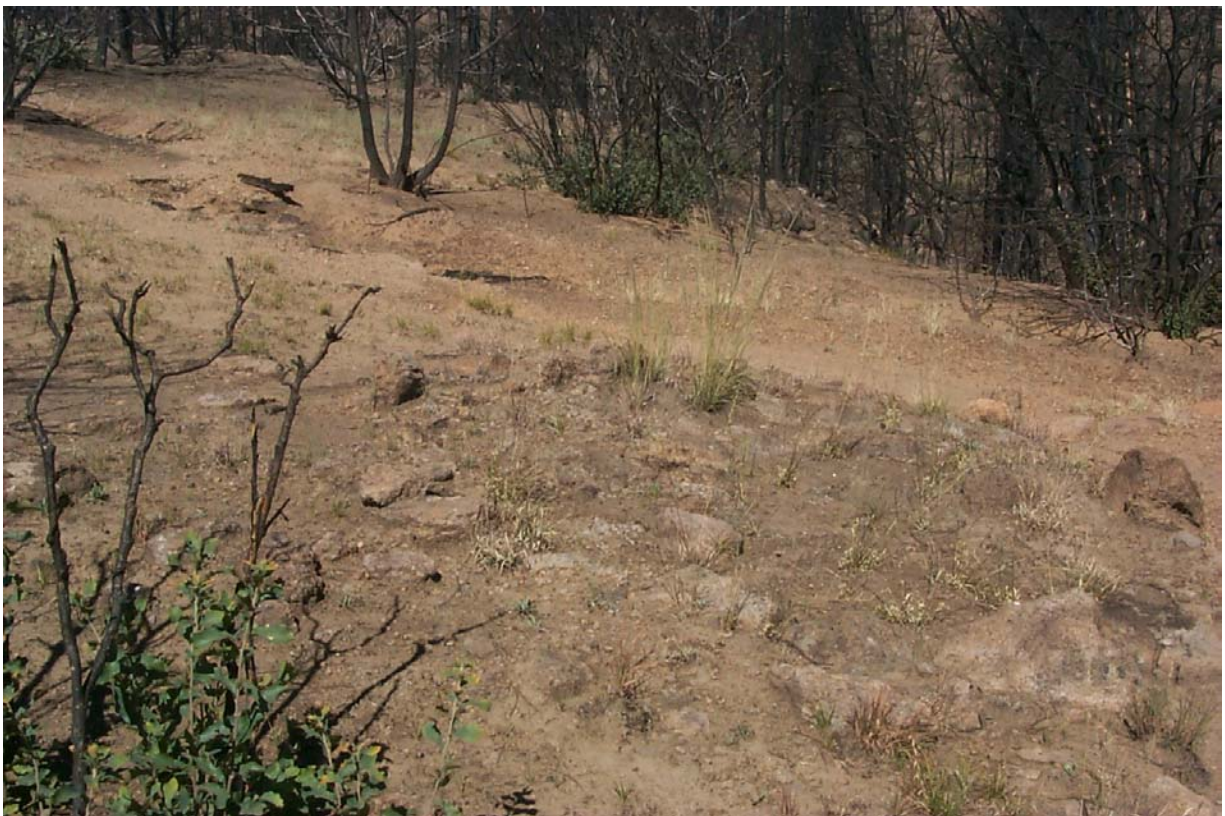
LA 86607. This site (Figure 10.3) was last visited in 1992 as part of the Environmental Restoration Project. The site consists of the remains of a two- to four-room structure of tuff blocks. It is situated on top of the ridge forming the south side of Cabra Canyon. A narrow hiking trail runs through the site. Seven tuff blocks from the site were, at some time in the past (circa 5+ years ago), placed across the trail to help prevent erosion. Previous observations on the ceramics of the site indicate that it dates to the Coalition period. The area around the site was severely burned, although there is little vegetation in the immediate site vicinity. Twenty percent of the masonry was soot damaged. Due to the trail and absence of duff around the site, there is a low erosional threat.

Figure 10.3. LA 86607, view of fieldhouse and modern trail, facing north.

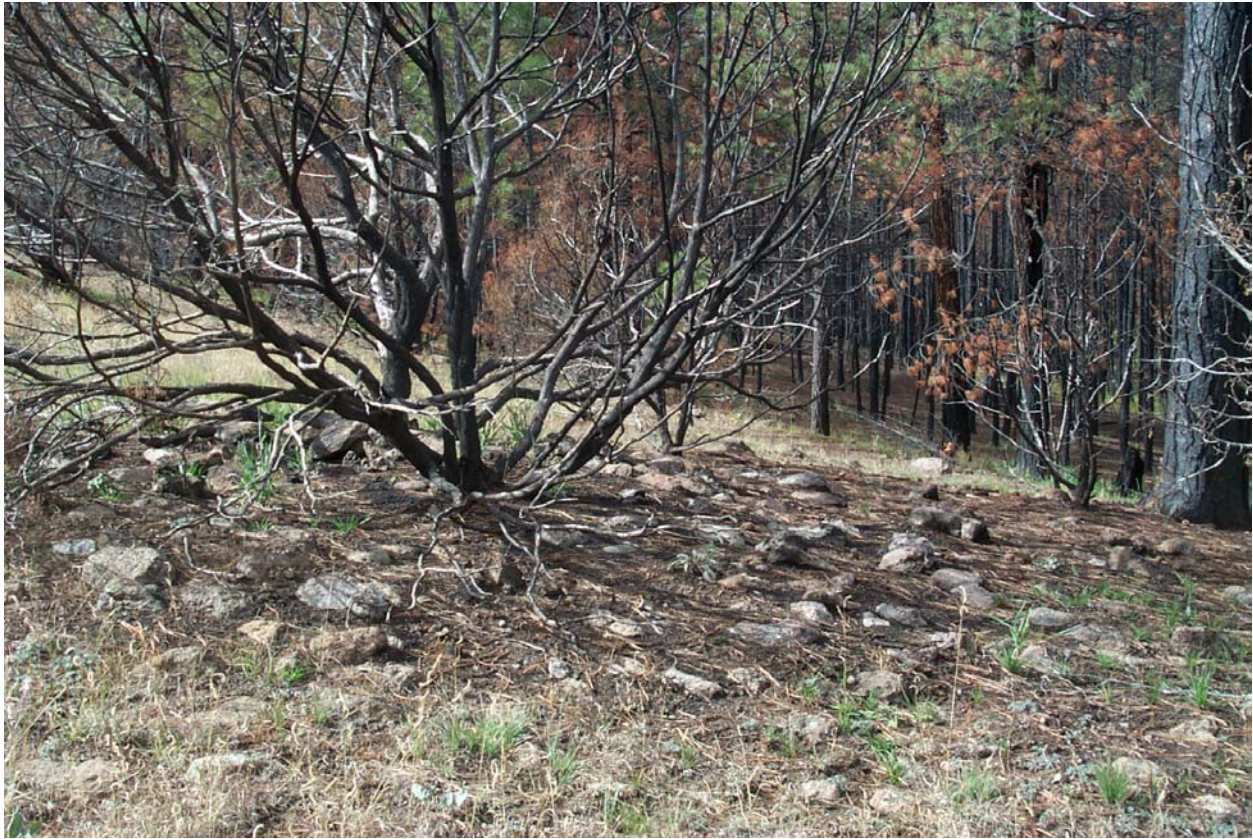
LA 135291 (BCH-1). This site (Figure 10.4) consists of a scatter (10 m by 10 m) of mostly unshaped tuff blocks. It is not clear if these blocks are the remains of a structure, a rock pile, or something else. The site is located just above the north-facing slope of the south bench of Rendija Canyon in a lightly forested

area. Several unidentifiable sherds and one obsidian flake were found at the site. This site is probably Ancestral Puebloan. The area below the site—the bench slope and canyon bottom—suffered severe burning, and there are two junipers in the center of the tuff blocks that were burned by the fire; these could damage the site if they fall. Otherwise, no burning occurred in the site area. Many of the masonry blocks are soot damaged.

Figure 10.4. LA 135291, view of rock feature, facing east.
